MONUMENT RECORD

Corner ID: Rich\_K09

Section Corner

Sections 09 & 16- T09N-R02W, 2nd P.M.

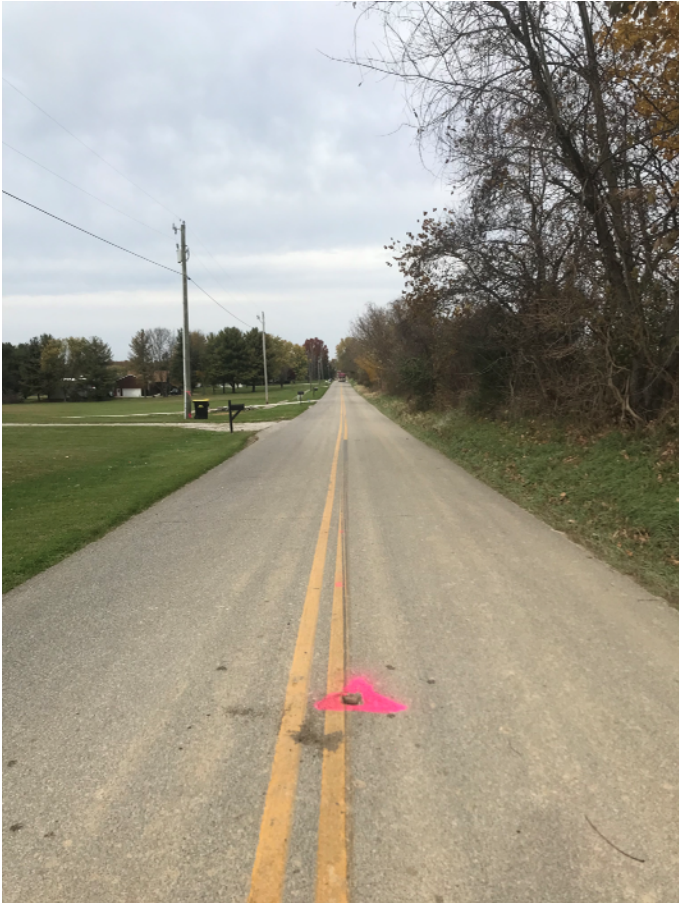
**MONUMENT:** Describe monument set or found (Include material type, scribing, distance above/below grade, dimensions.)  
*Railroad spike found 3 inches below grade in the centerline of Louden Road*

Photo Orientation & Description: *Looking North at K-09*

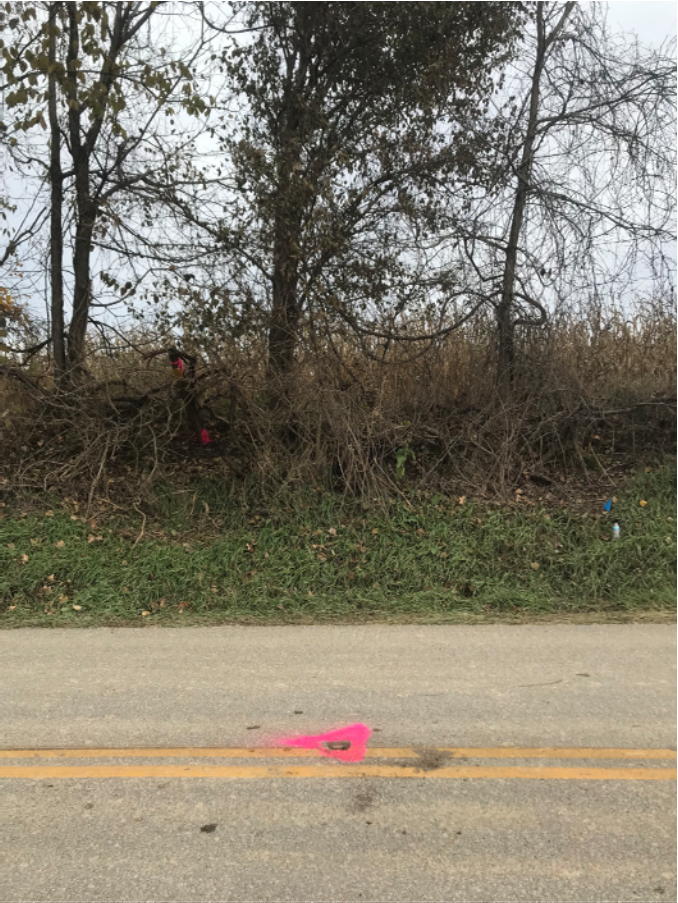
**OTHER EVIDENCE:** Describe corner location relative to nearby features and how to reach the corner location – note fences, roads, timber cutting lines, mow lines, clearings, plantings, streams, topo changes, etc.  
*Railroad spike was found in the North-South running centerline of Louden Road, North-South running wire fence on the East side of Louden Road*

**MONUMENT PRESERVATION:** Describe work done to preserve existing monument. Stone mounds should be placed around monuments when stones are readily available. Paint corner stones but not the scribing. A Monroe County “PROTECT NEARBY SURVEY MARKER” sign shall be attached to a steel post when practicable. Note location and relation of corner to sign.  
*A Monroe County “PROTECT NEARBY SURVEY MARKER” sign was found on the West side of a wood post to the East of the railroad spike*

Photo Orientation & Description: *Looking East at K-09*
